VALVE CONDITION ASSESSMENT USING NEW TECHNOLOGY

Sagar Khadka

ACTEW Water, Canberra, ACT, Australia

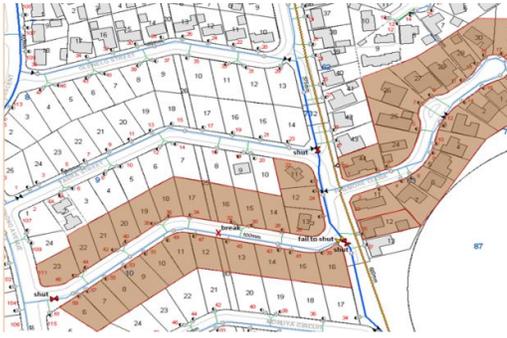
Figure 1: Consequences if DN100 valve failed to shut, 41 houses affected instead of 20

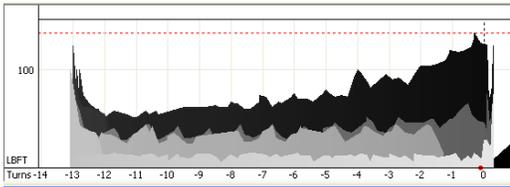
- 223 (9.02%) valves were very stiff. These valves were operated from fully open to closed and then back to fully open a few times until the torque required to operate the valve is minimal. They can now be safely operated manually. In fig 2, the number of turns is shown on the X axis and torque (LBFT) on the Y axis. Different colours in the graph show the number of times the valve was operated. The valve shown in Fig 2 was operated four times where the initial torque required to operate valve was around 90 LBFT but after operating four times, it required only 20 LBFT. This valve will be very easy to operate manually in the future.

Figure 2: Stiff valve but smooth after operation

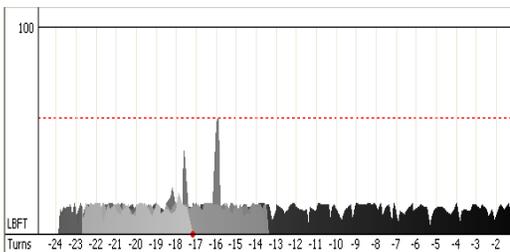
- Identified 15 broken valves (1%) which couldn't be used for isolation. All the broken valves were replaced immediately.

Figure 3: Broken valve

Broken valves will spin indefinitely with less torque and need to stop it manually.

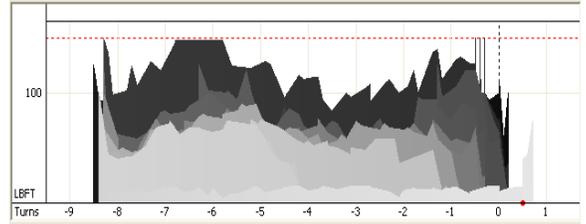
- 30 (1.2%) valves were very stiff and are still stiff after operating a few times. The torque required to operate those valves is still significantly high and they cannot be operated manually. These valves are listed for replacement.

Figure 4: Valve considered for replacement

In the above figure, the valve was operated five times to see if the valve could be operated with minimal torque after operating few times. There was no sign of improvement and this valve will be very difficult to operate manually. Replacement of this valve is required.

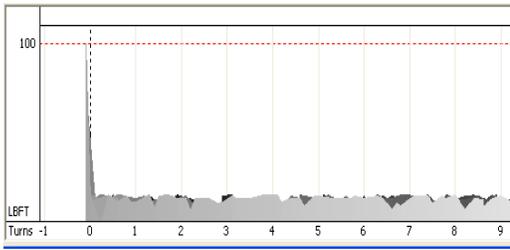
It was interesting to see that 4% (99) of the valves were left closed or partially closed after maintenance. If the valves are left shut, it creates dead ends and there may be stagnant water that will create water quality issues. All these closed valves were left open after exercising. One critical valve and a few big valves (above DN300) were also found shut and this information was also used to calibrate the water reticulation model.

Figure 5: Closed valve and left open after exercise

The position of “0” indicates the initial status of the valve. If the “0” is in the LHS and is spinning towards the RHS, then the valve is closing.

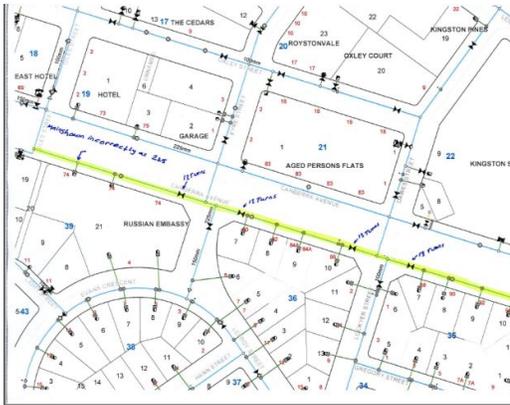
- 7% of new valves that had been replaced reactively within last five years had not been updated in the GIS.
- 85 valves and the corresponding water mains were incorrectly sized in the GIS and thus in the water reticulation model. Incorrectly sized mains can be critical for fire flow analysis. The number of turns is used to verify the size of water main and valve information within the GIS has been updated accordingly.

Figure 6: Mains and valves incorrectly shown as DN225 for DN150 main and valves
