# SCITECH NEPAL

*Journal of Scientific and Technical Studies*

VOLUME 18 | ISSUE 1 MARCH 2026

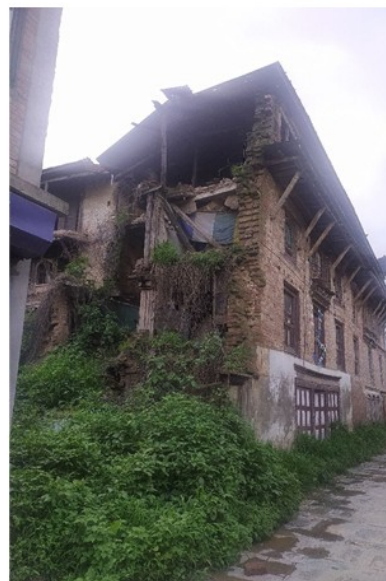
From Figure 3 it is clear that 45% (maximum) of the houses were partitioned and left out. The owners of the house migrated either to the agricultural land or to the other city. Those dwellings that are visited by the owners are still in livable conditions (Figure 5). And which are not visited by the owners are deteriorating day by day due to lack of maintenance (Figure 6).

Figure 6: Deteriorating

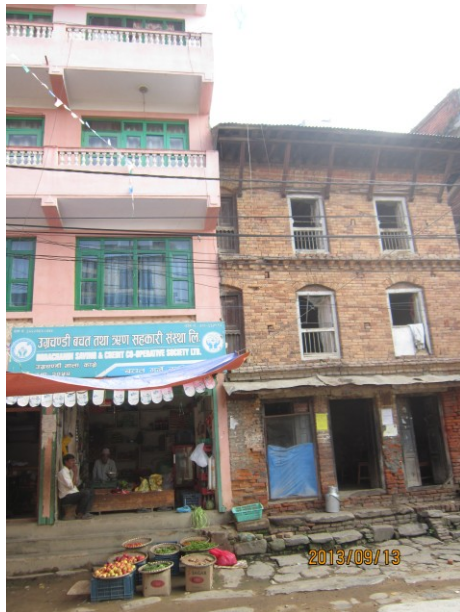
Another 20% case found was after vertical division one owner rebuilt the house using modern materials and the other owner(s) left it as it was (Figure 8). This causes two problems, one is that traditional architecture gets disturbed. Another is houses become structurally weak. New dwellings are taller and use modern materials and their widths are smaller resulting in slender tall houses. Another left part of the house also becomes weak. Both cases are vulnerable during earthquakes.

Figure 8 Partial New Construction

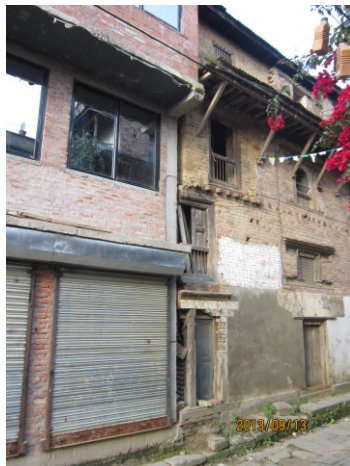
22% of the surveyed houses are found to be reconstructed using modern materials after vertical division (Figure 10).

Figure 10 Before Demolition

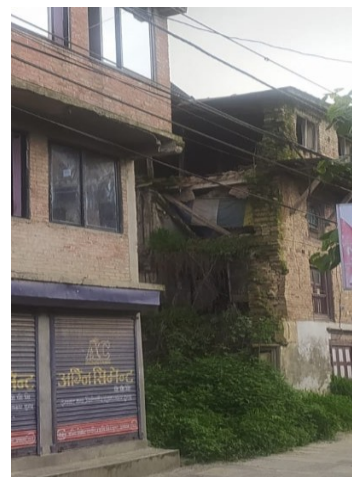
The third case includes 12% of dwellings demolished after vertical division. The reason behind it is migration and shifting to nearer agricultural land, regular maintenance costs are higher so instead the owner demolished it (Figure 12). Another reason is traditional windows cost more and to sell those

Figure 9 one section demolishes
